Emergency Response to the Edenville Dam Failure

Dam Stabilization and Flood Risk Mitigation

MSPE Annual Conference

May 2021

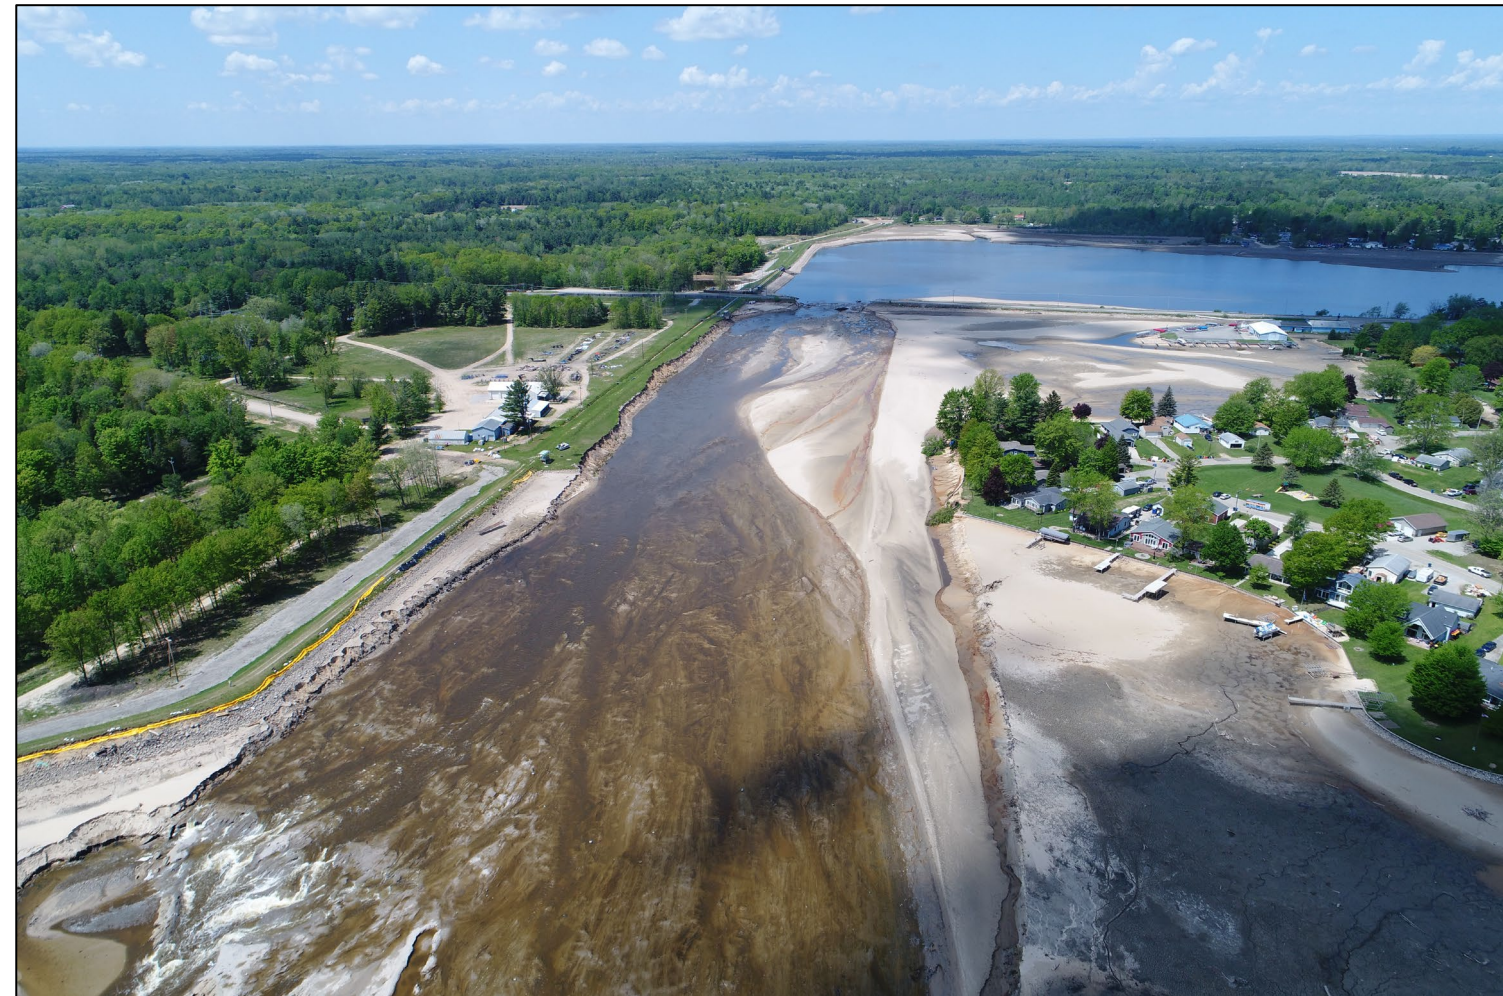
Impact to Dam Embankment and Causeway

- 11,000 people evacuated
- 2,500 structures damaged

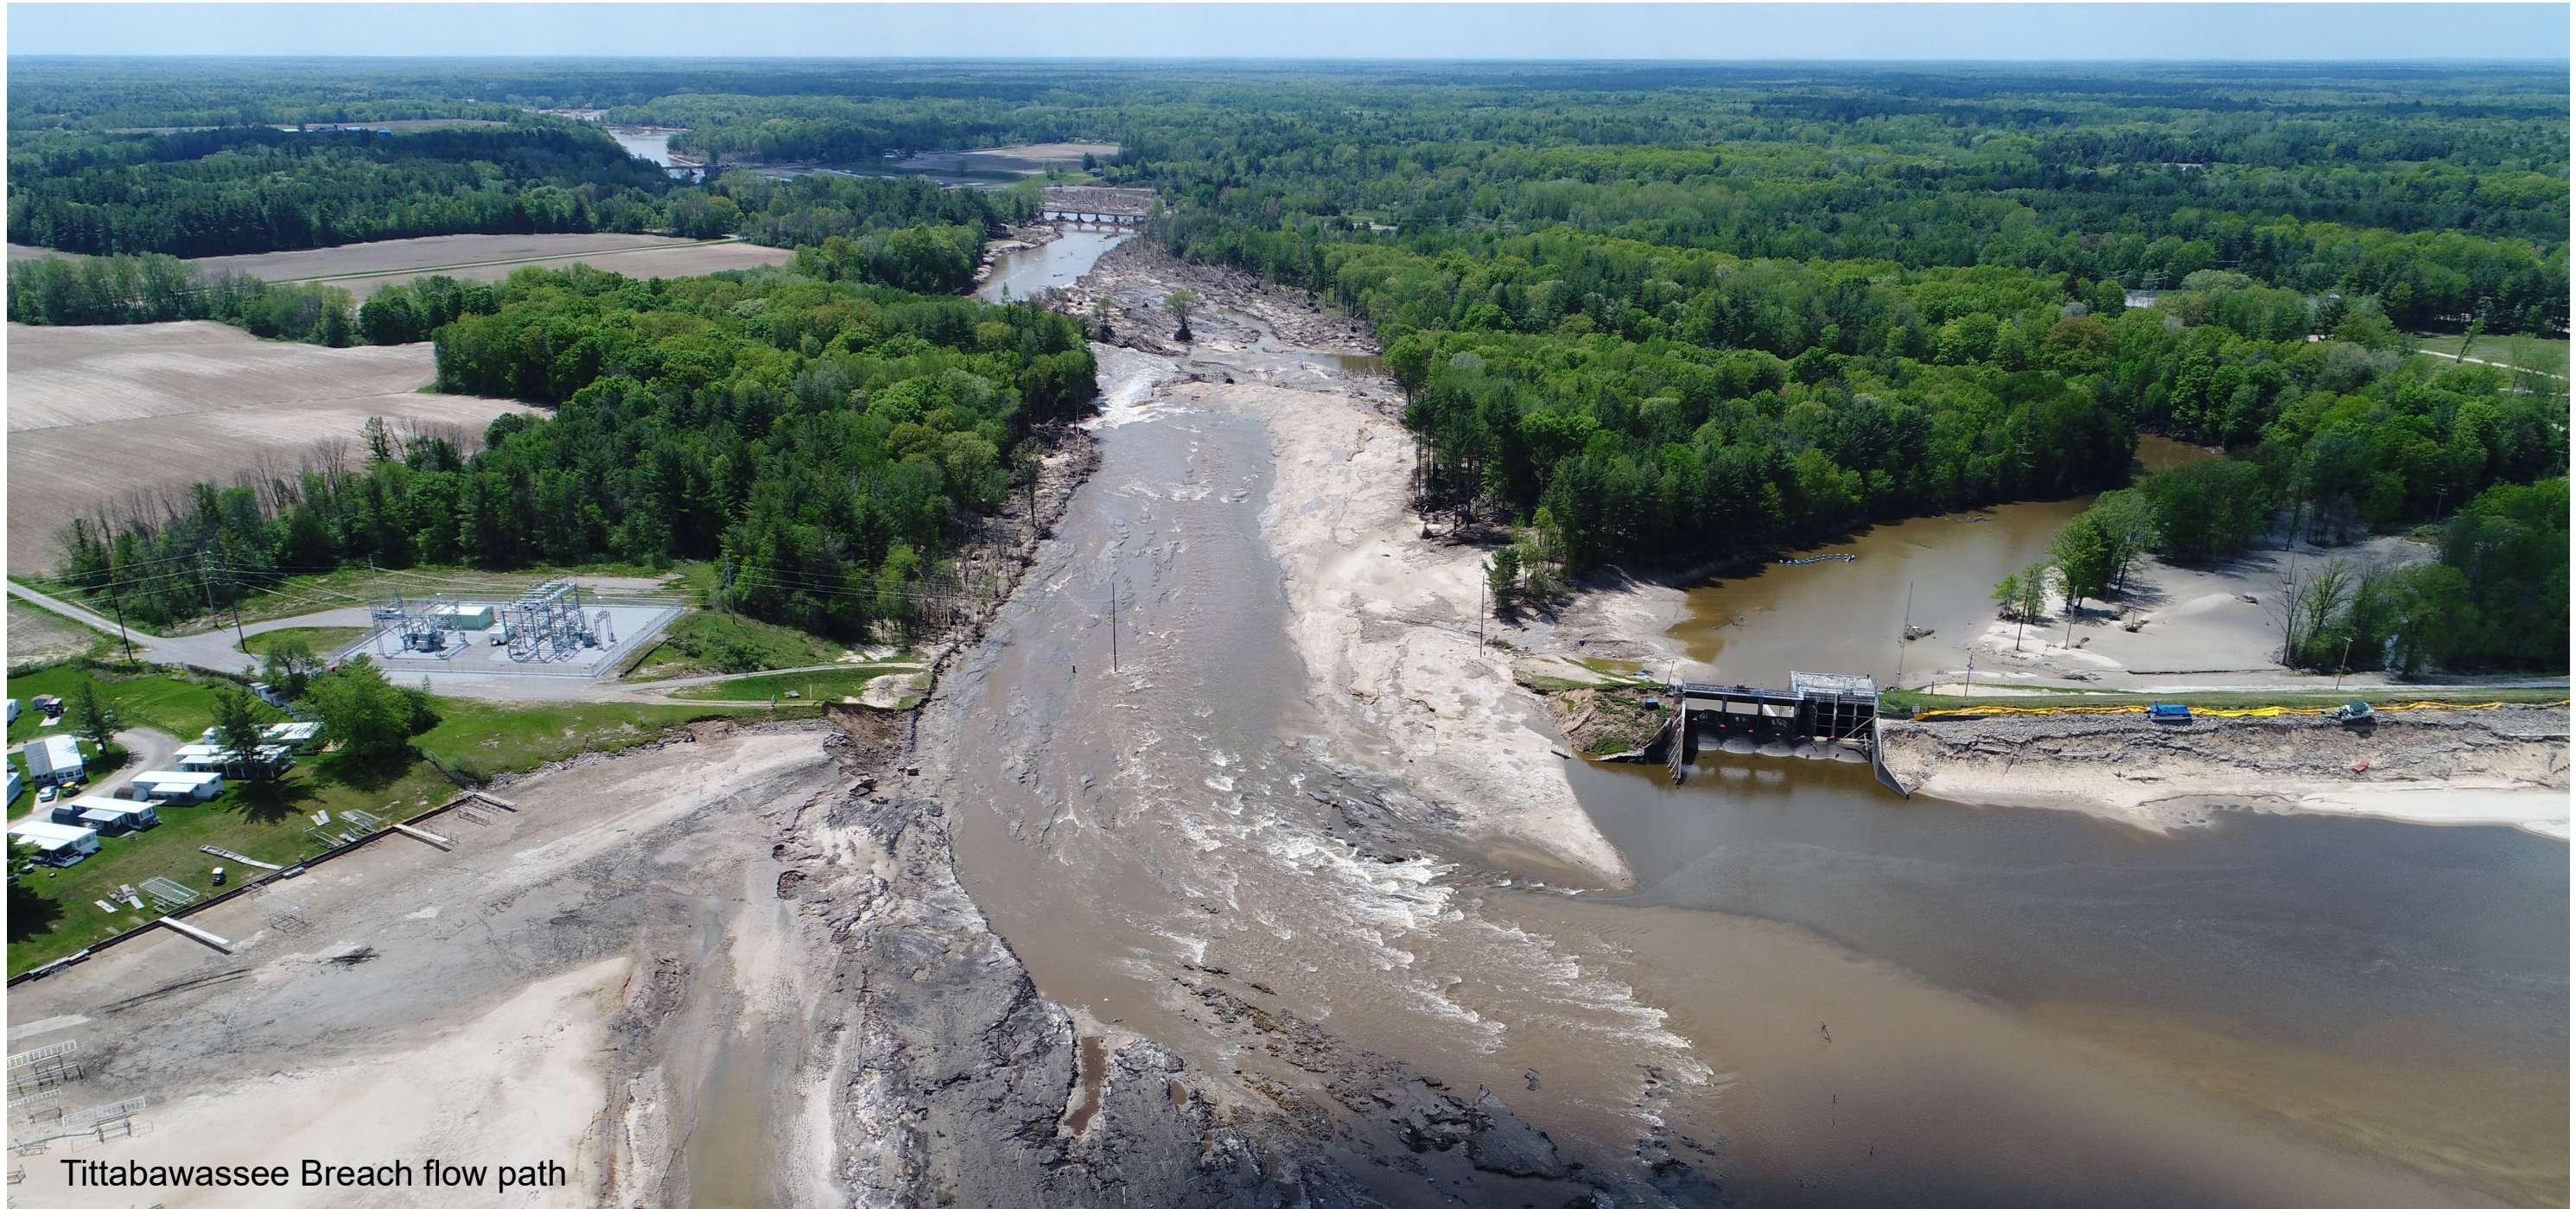
Breach Flow Path

Tittabawassee Breach flow path

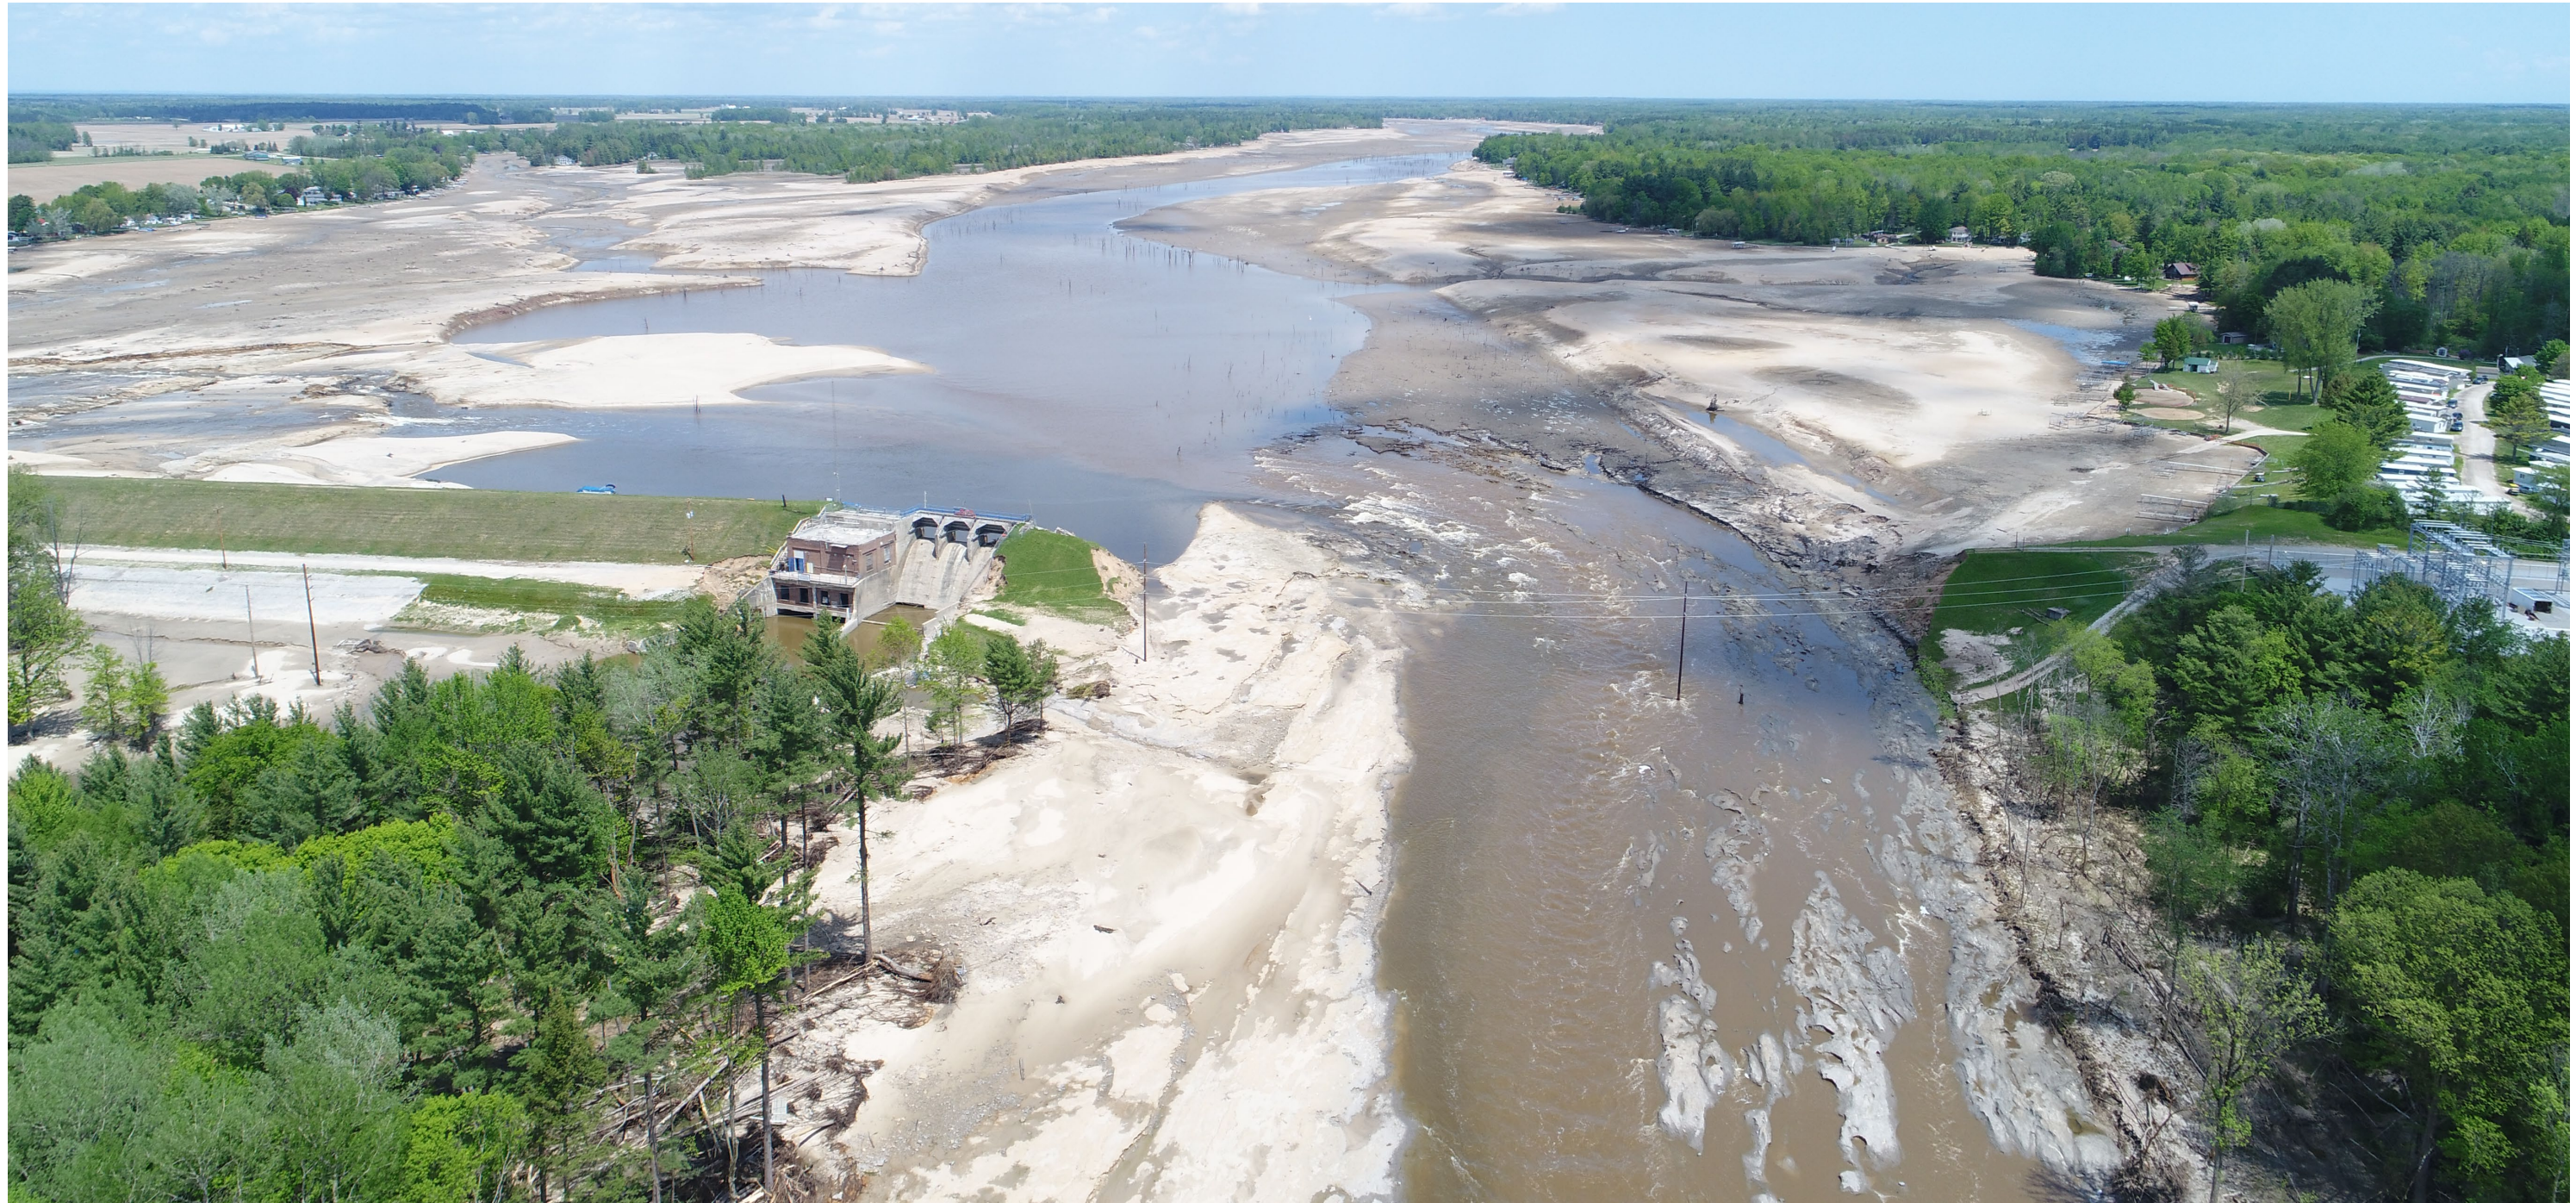
Breach Flow Path

Breach flow path appears higher than natural channel
